## RELEASE NOTES

**Product: HTI-404 (ref. 3864)  
HTI-424 (ref. 3863)**

**Version: 3.0.7**

**Date: 11/06/2020**

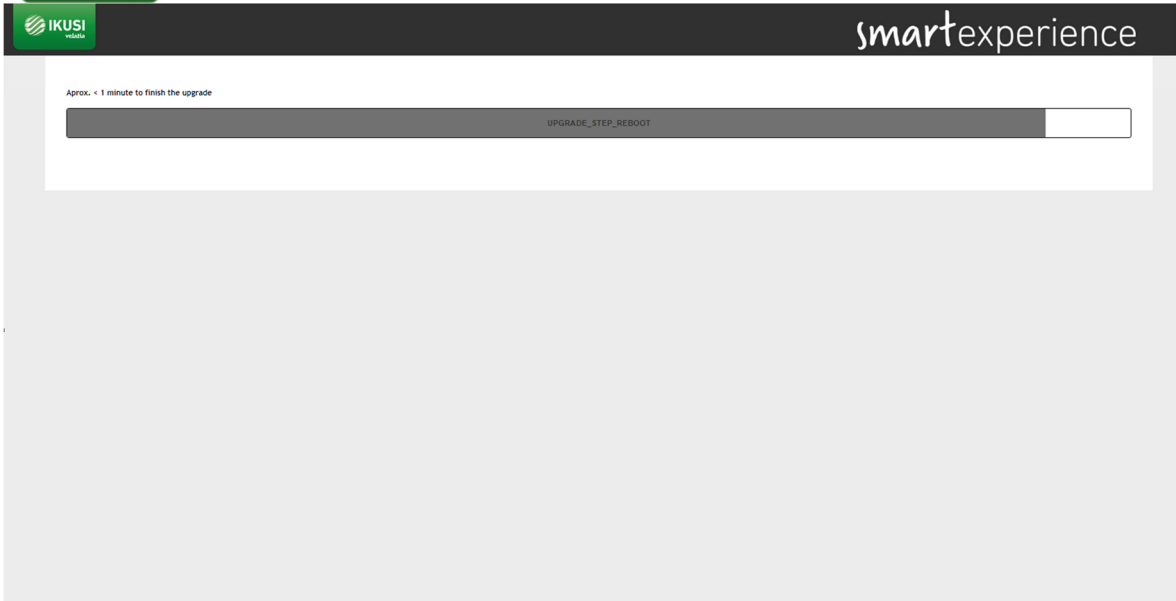
- Select the firmware through Add Firmware File button. After that, push Upload button. Once the firmware has been uploaded, it will appear in the AVAILABLE FIRMWARE VERSION section.
- Push the Install button associated with the desired firmware version.
- After pushing Install button, the upgrade progress screen will open.
