## RELEASE NOTES

**Product:** HTI-404 (ref. 3864)  
HTI-424 (ref. 3863)

**Version:** 3.4.11

**Date:** 22/03/2022

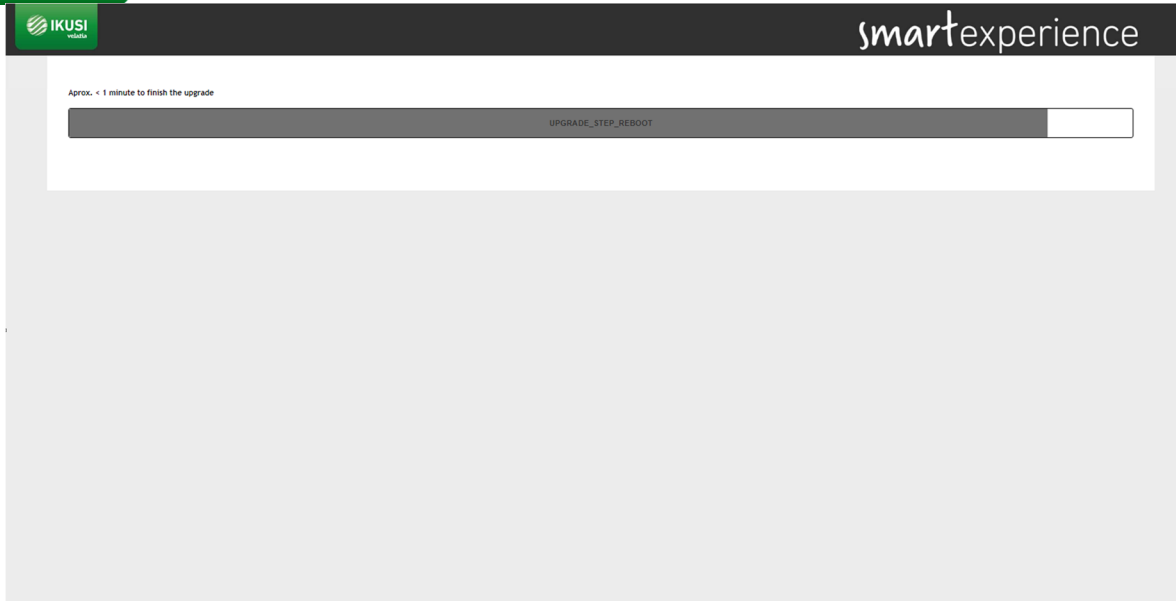
- Select the firmware through Add Firmware File button. After that, push Upload button. Once the firmware has been uploaded, it will appear in the AVAILABLE FIRMWARE VERSION section.
- Push the Install button associated with the desired firmware version.
- After pushing Install button, the upgrade progress screen will open.
