RELEASE NOTES

**Product: HTI-404 (ref. 3864)
HTI-424 (ref. 3863)**

Version: 3.0.4

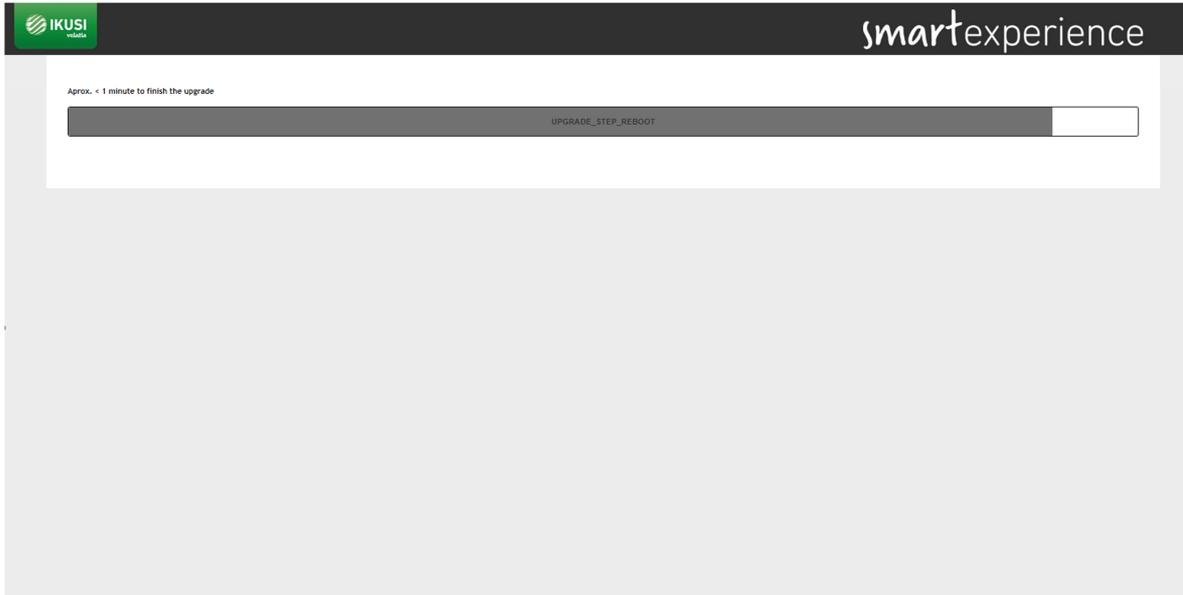
- Select the firmware through Add Firmware File button. After that, push Upload button. Once the firmware has been uploaded, it will appear in the AVAILABLE FIRMWARE VERSION section.
- Push the Install button associated with the desired firmware version.
- After pushing Install button, the upgrade progress screen will open.

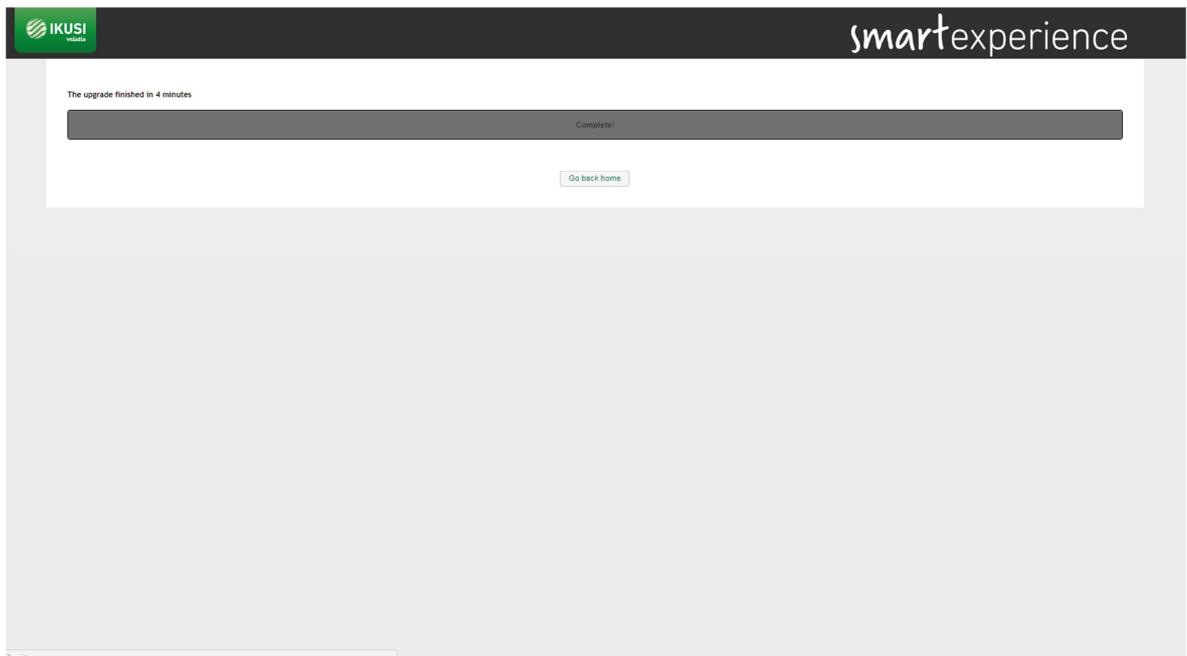
- At the conclusion of the upgrade (10' approx), a message will appear as follows:
