RELEASE NOTES

Product: HTI-404 (ref. 3864)
HTI-424 (ref. 3863)

Version: 3.4.7

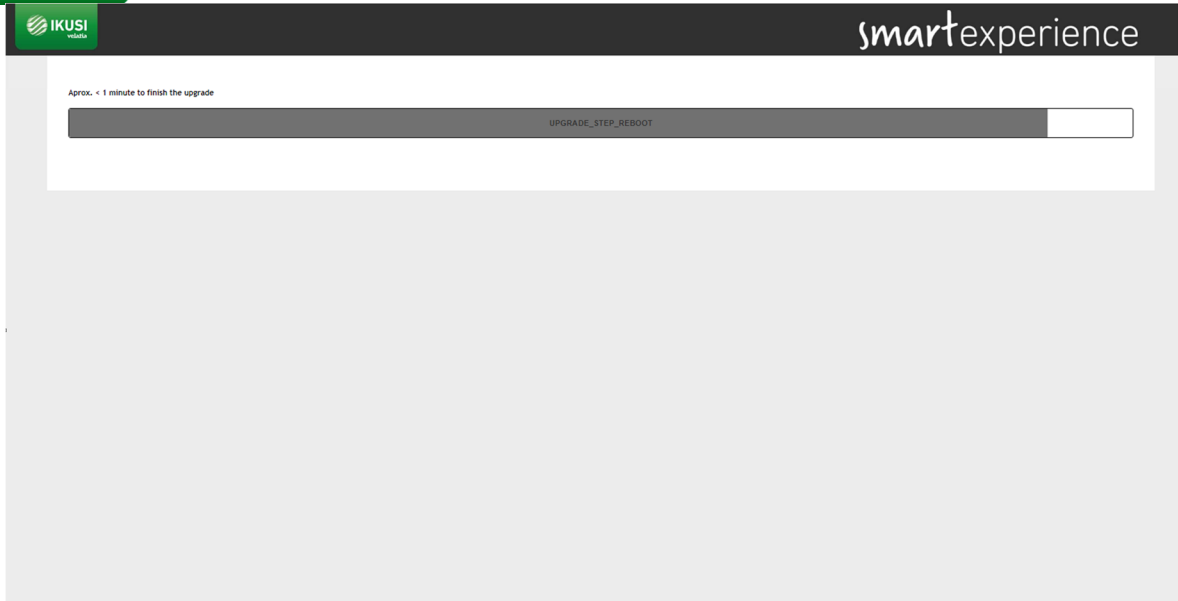
- Select the firmware through Add Firmware File button. After that, push Upload button. Once the firmware has been uploaded, it will appear in the AVAILABLE FIRMWARE VERSION section.
- Push the Install button associated with the desired firmware version.
- After pushing Install button, the upgrade progress screen will open.

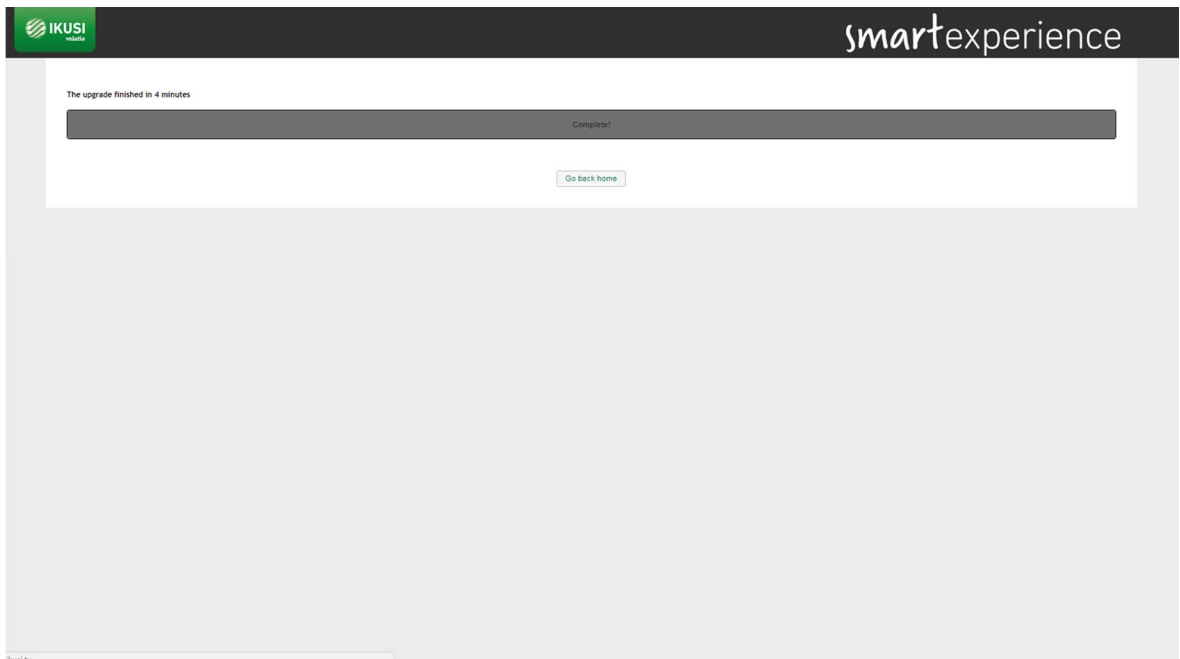
- At the conclusion of the upgrade (10' approx), a message will appear as follows:

- Push Go back home button. The web interface will redirect you to Overview screen.
